# Situation Photo Log

Thursday, October 4, 2012

Kalamazoo River / Enbridge Spill

Prepared by:  
Larry Rader  
START-USEPA  
Situation Unit Leader

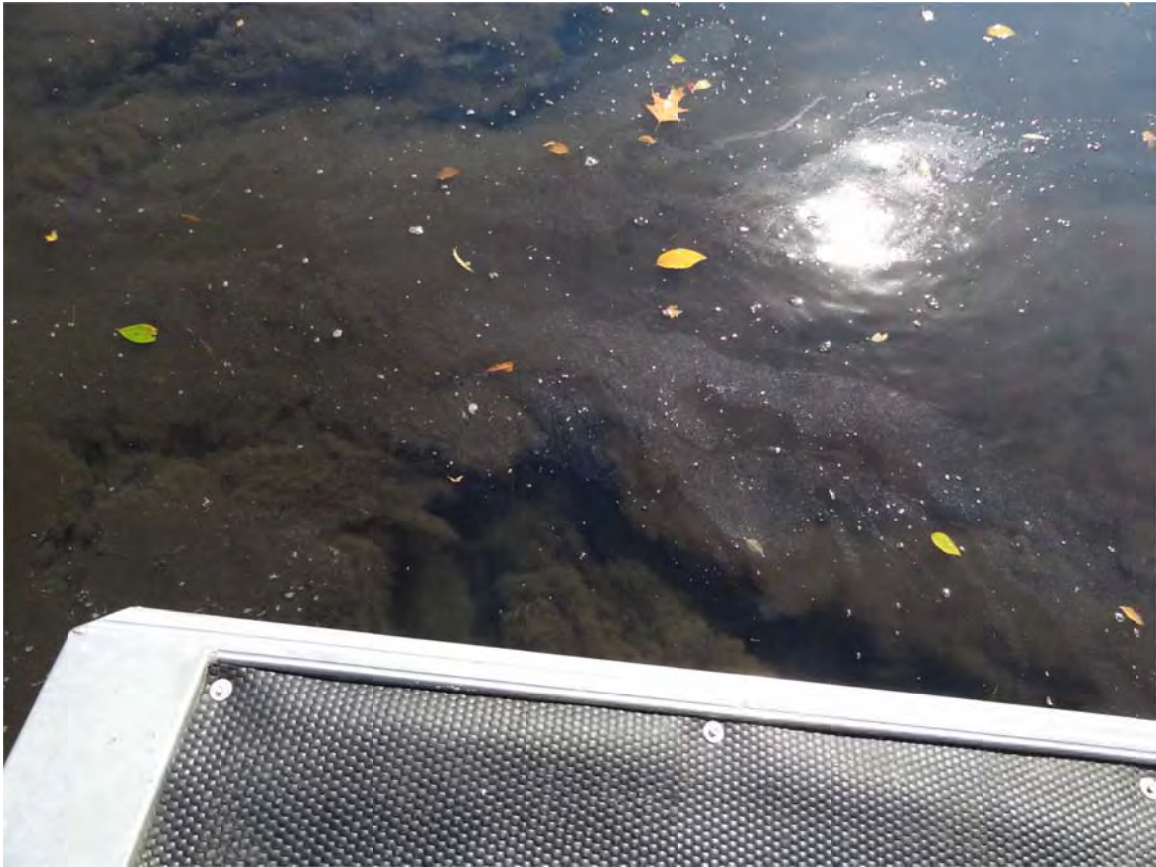
1. MP 4.5 Lily Pad area, sheen observed following boat agitation of sediment.

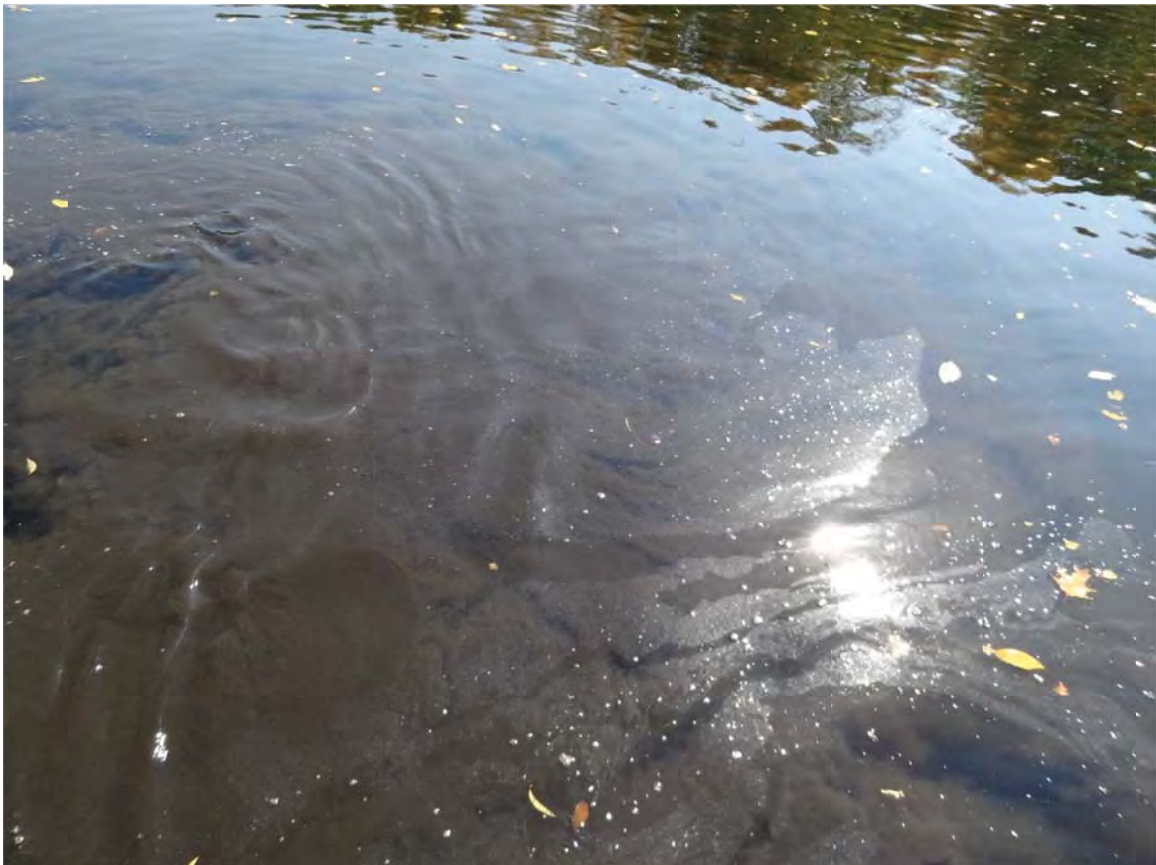
2. MP 4.5 Lily Pad area, sheen observed following boat agitation of sediment.

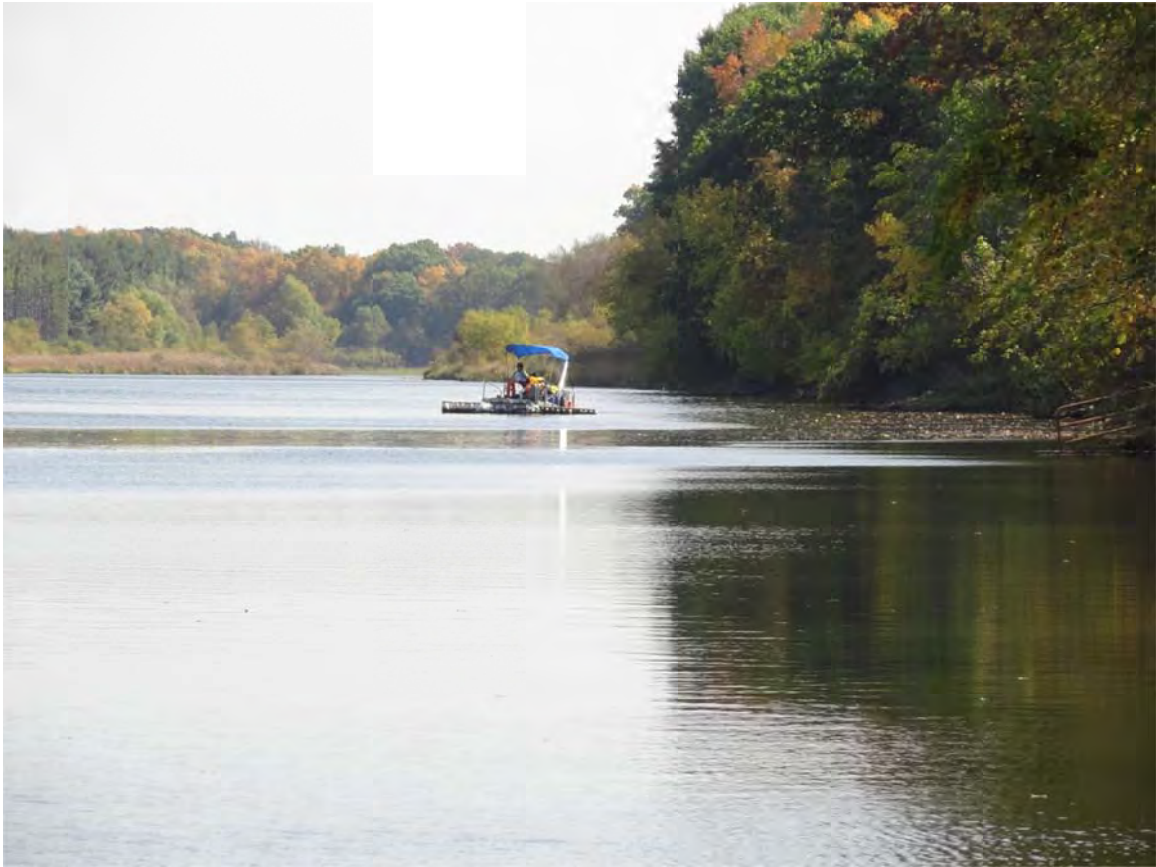
3. MP 5.25 LDB, sheen sweeper boat observed operating along LDB.

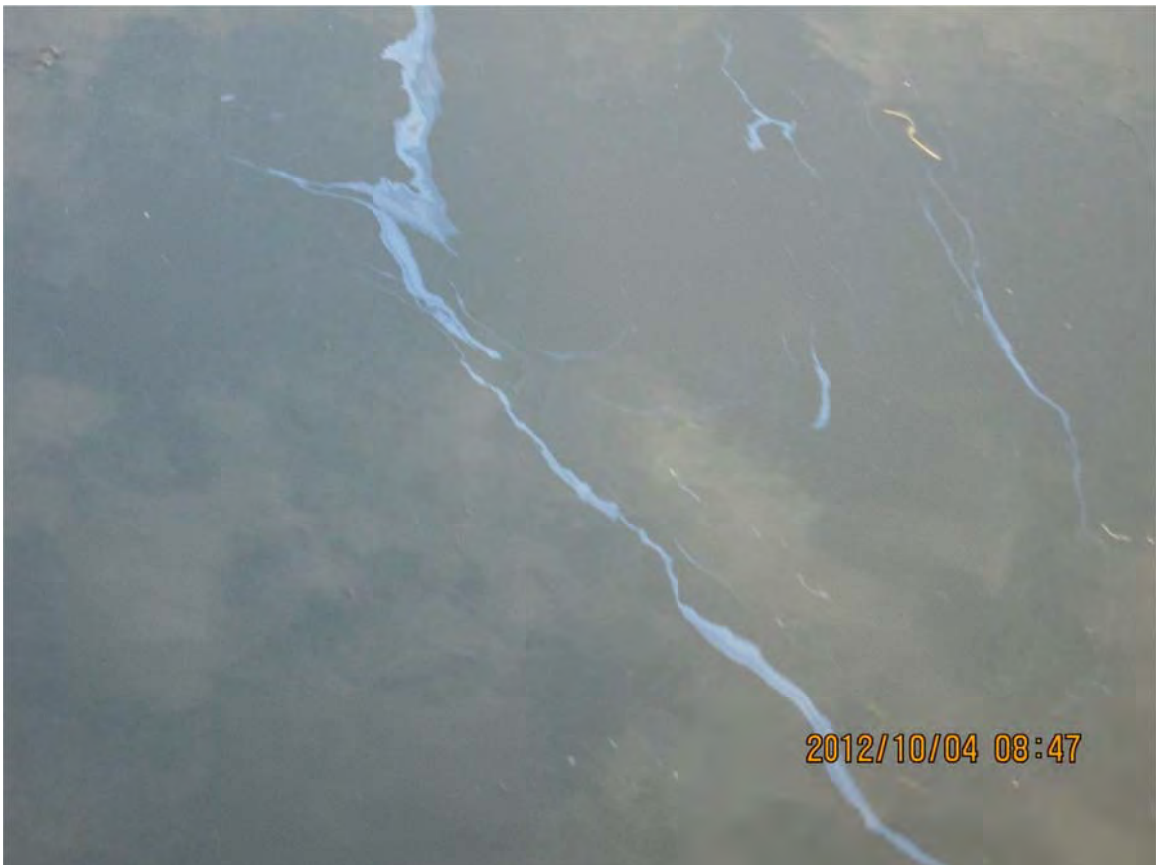
4. MP 5.25 LDB, sheen and tar globules observed along LDB.

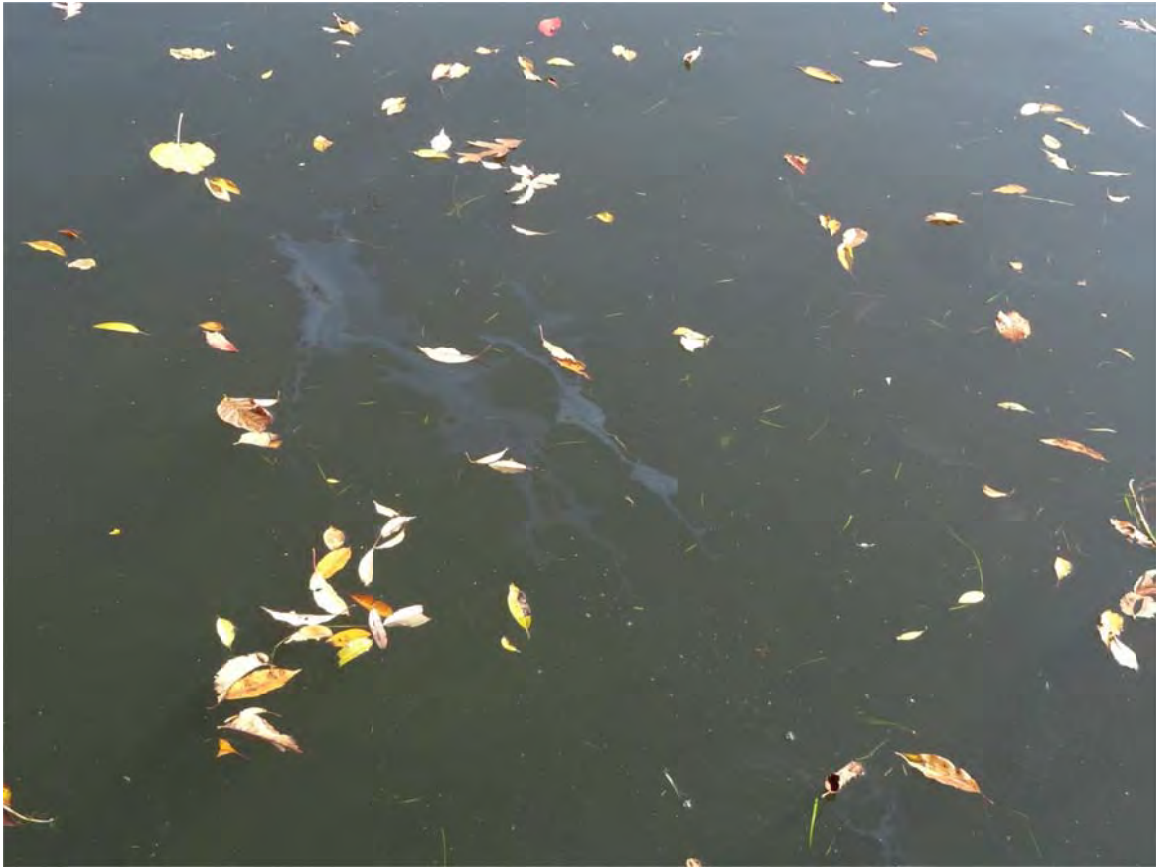
5. MP 5.63 RDB, sheen and tar globules observed upstream of trestle near pyramids.

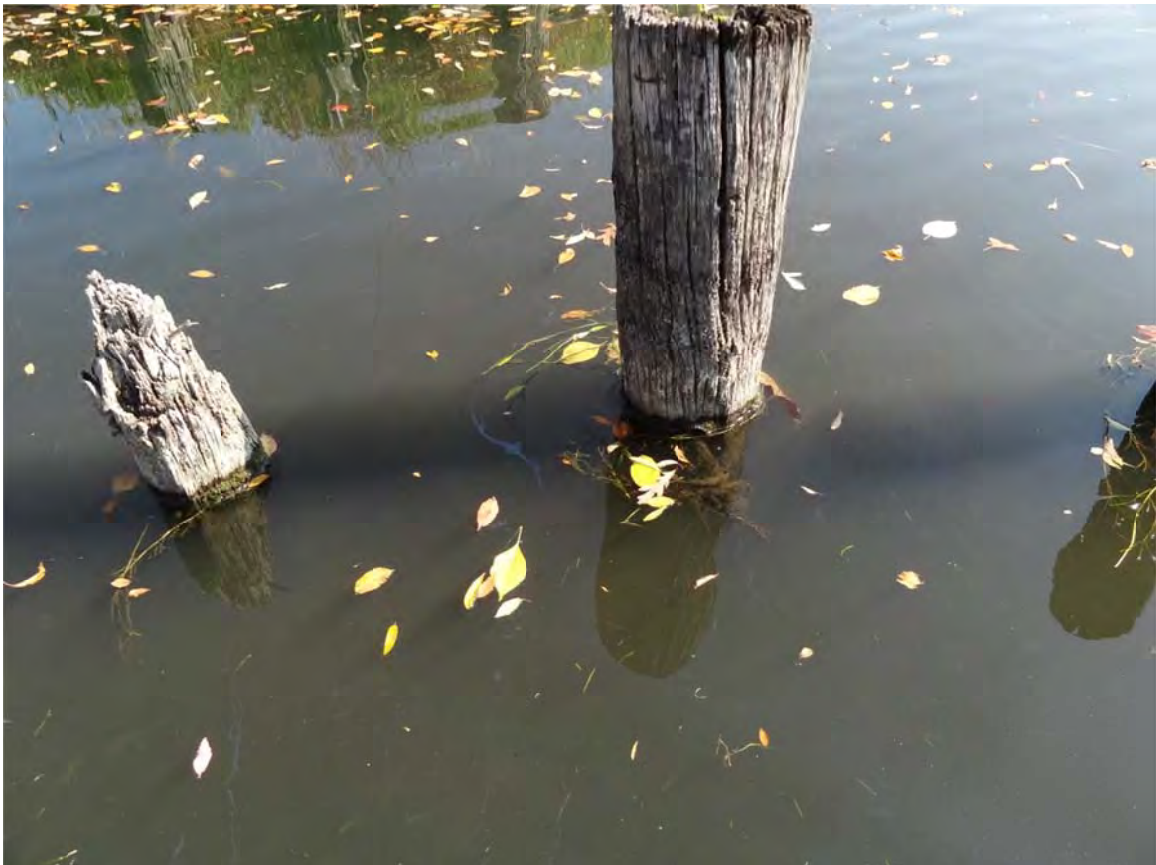
6. MP 5.63 RDB, sheen ribbons observed along former utility poles at trestle.

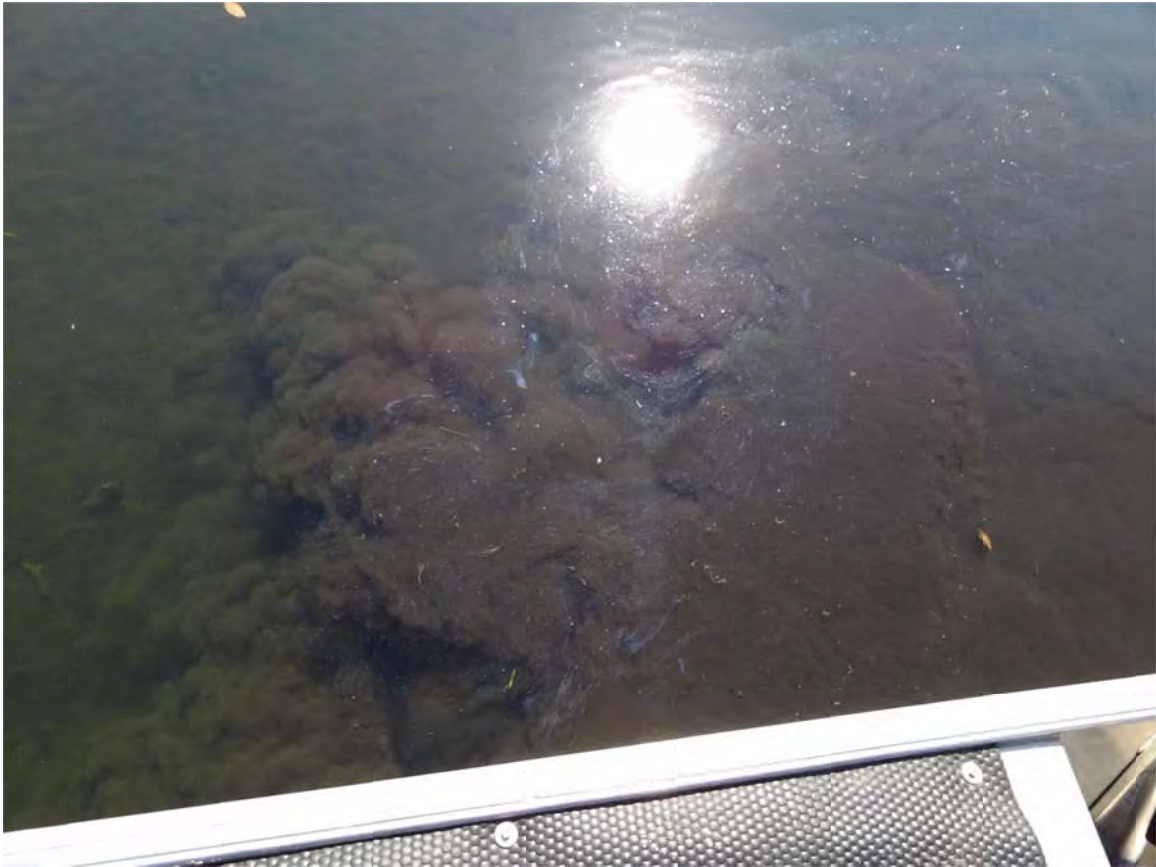
7. MP 5.75, sheen observed along Ceresco containment boom following agitation by boat.

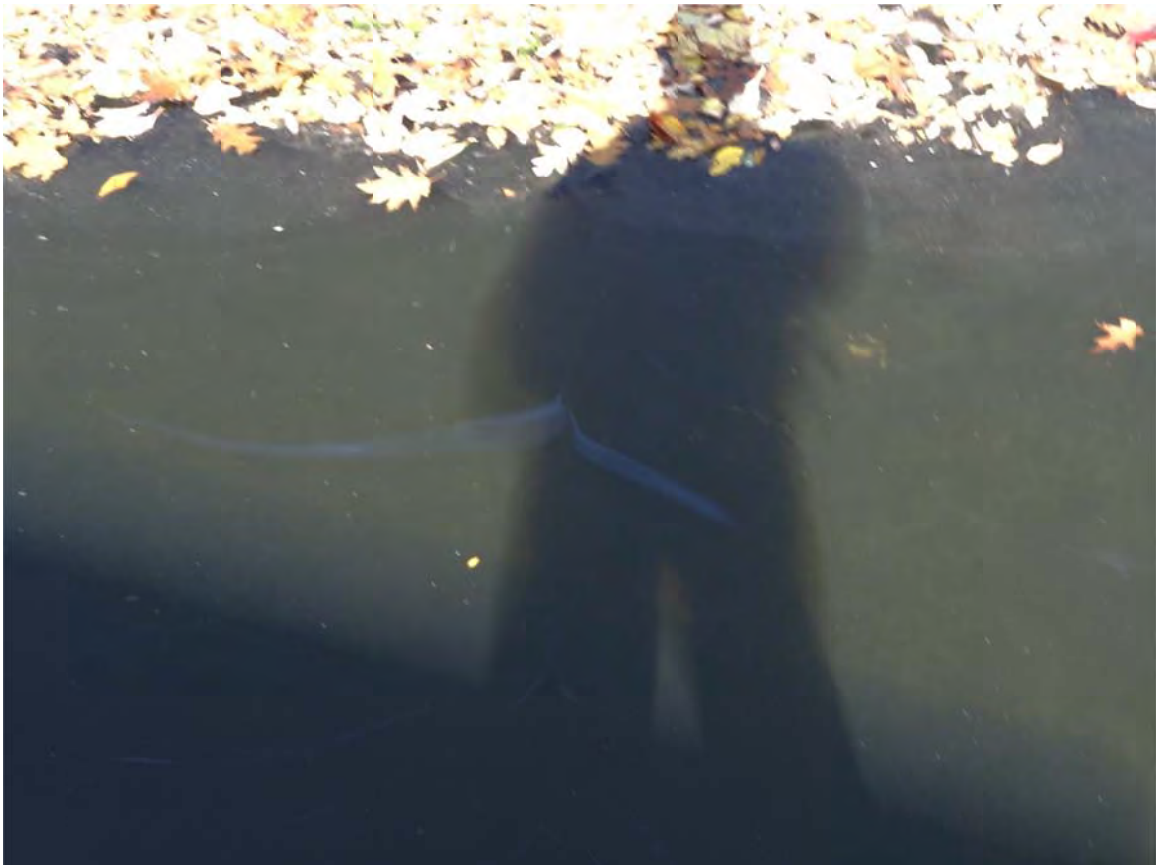
8. Sheen ribbons and tar globules observed along Ceresco Dam control point.

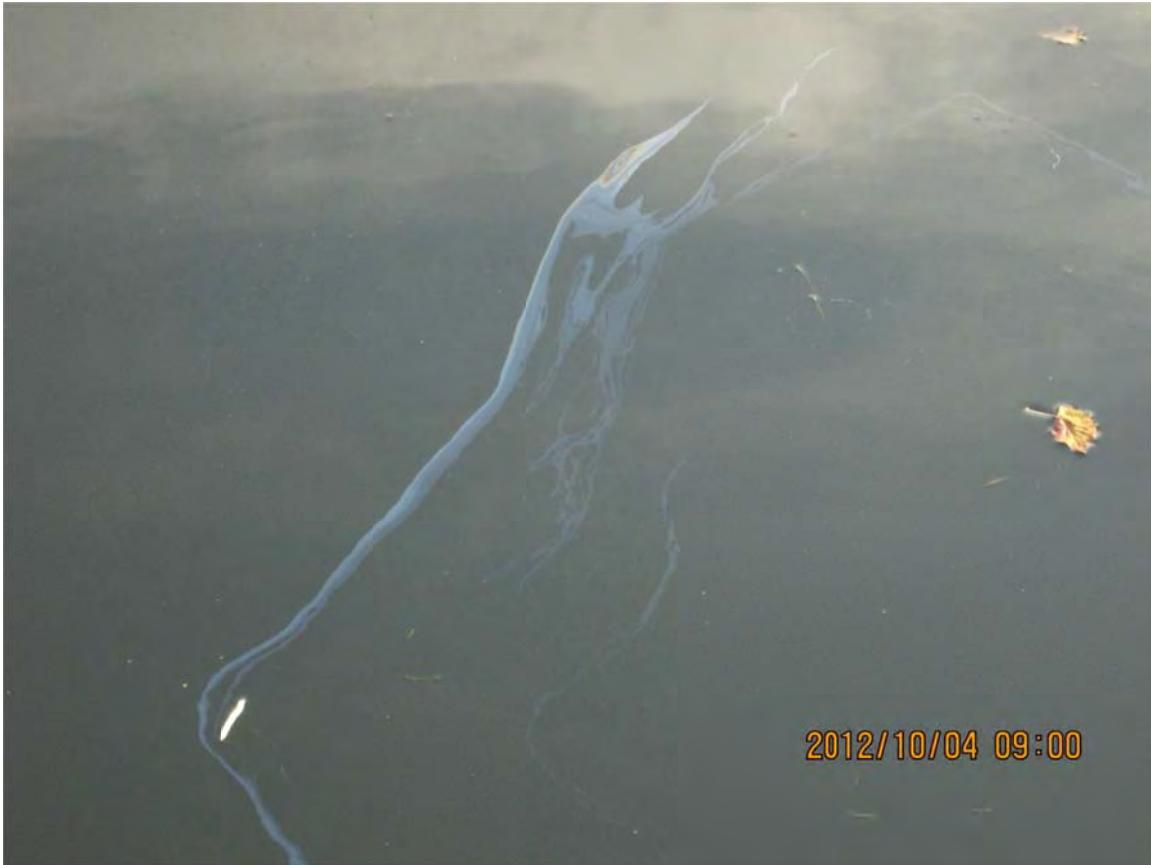
9. Sheen ribbons and tar globules observed along Ceresco Dam control point.

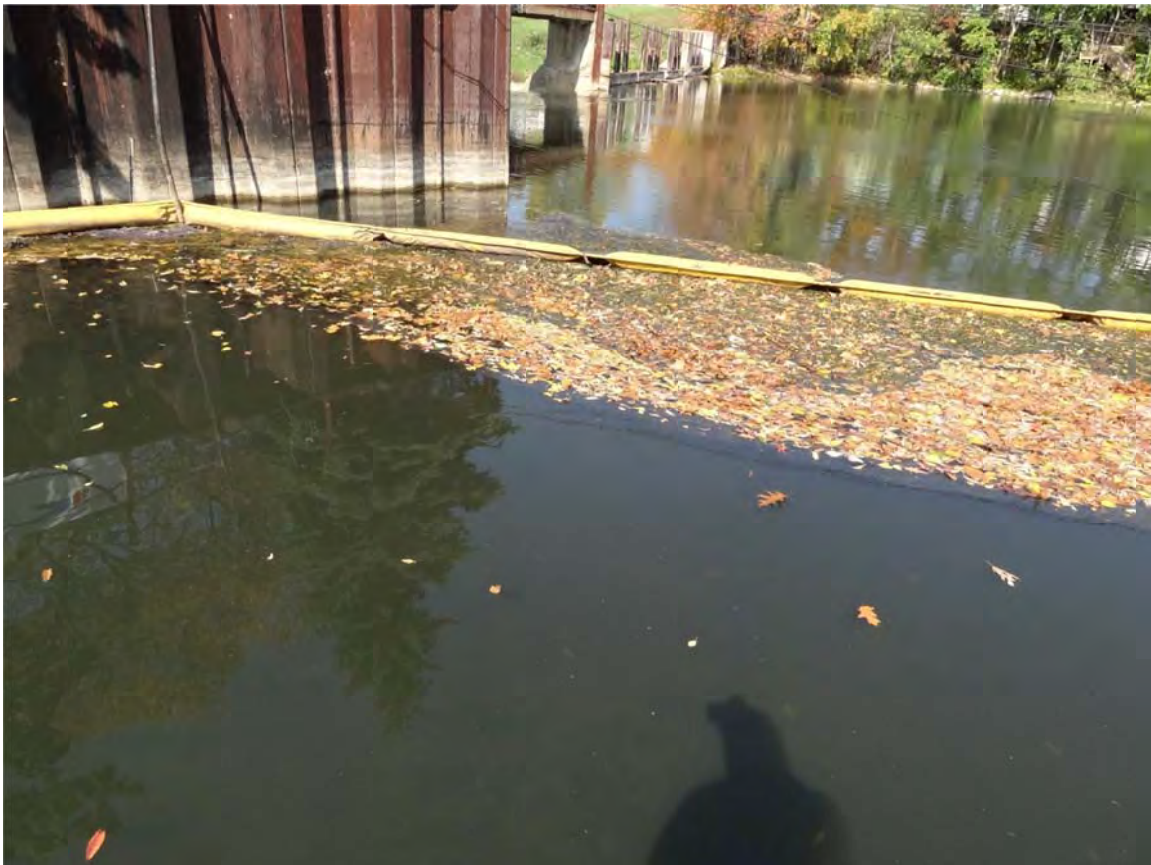
10. Sheen and debris within containment at Ceresco Dam.

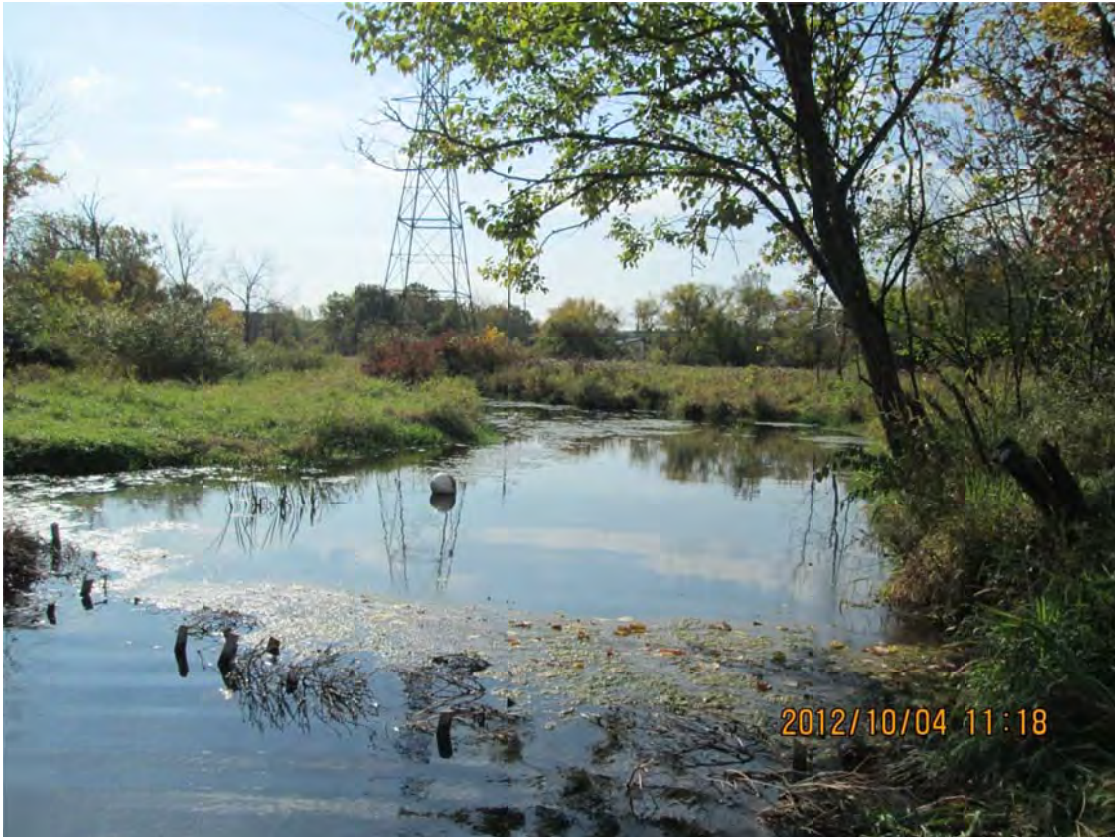
11. MP10.75 sediment trap. Small sheen ribbons observed behind sediment trap structure.

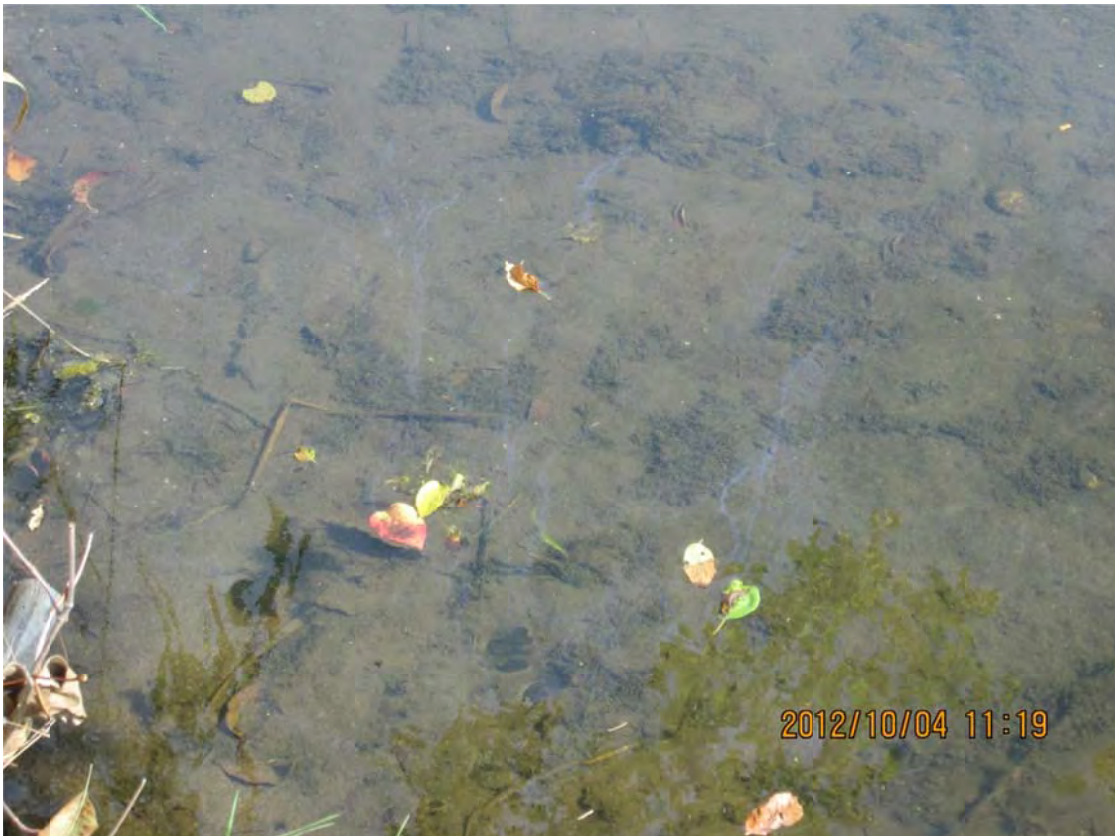
12. MP10.75 sediment trap. Small sheen ribbons observed behind sediment trap structure.

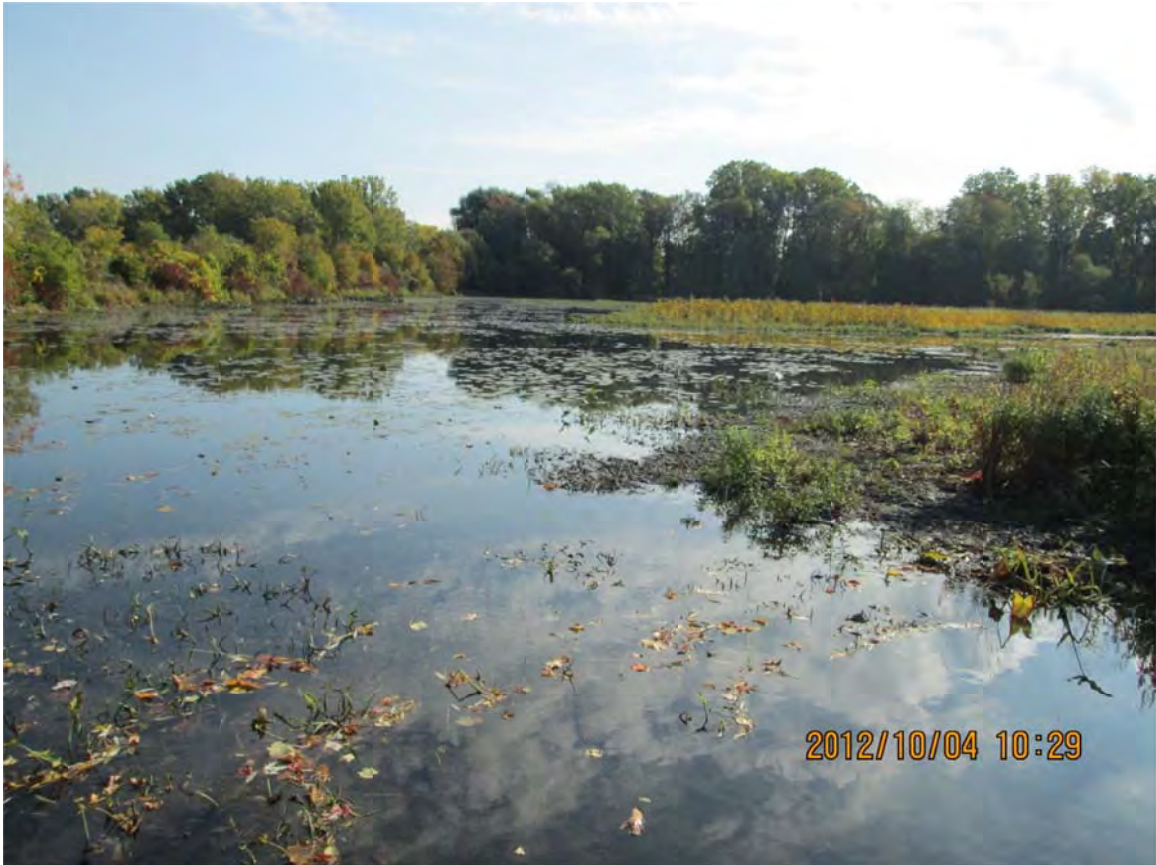
13. MP 15.5 south Mill Pond. Sheen and tar globules observed.

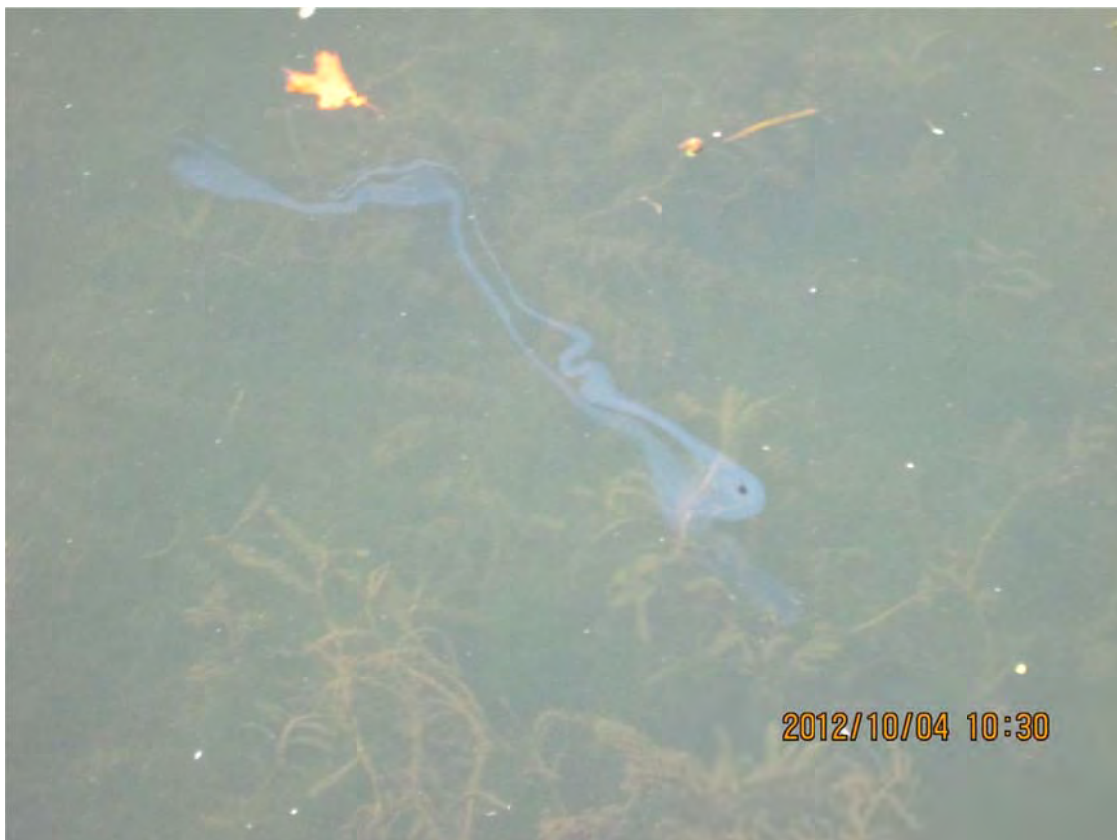
14. Sheen and debris observed near MP 15.5 RDB South Mill Pond.

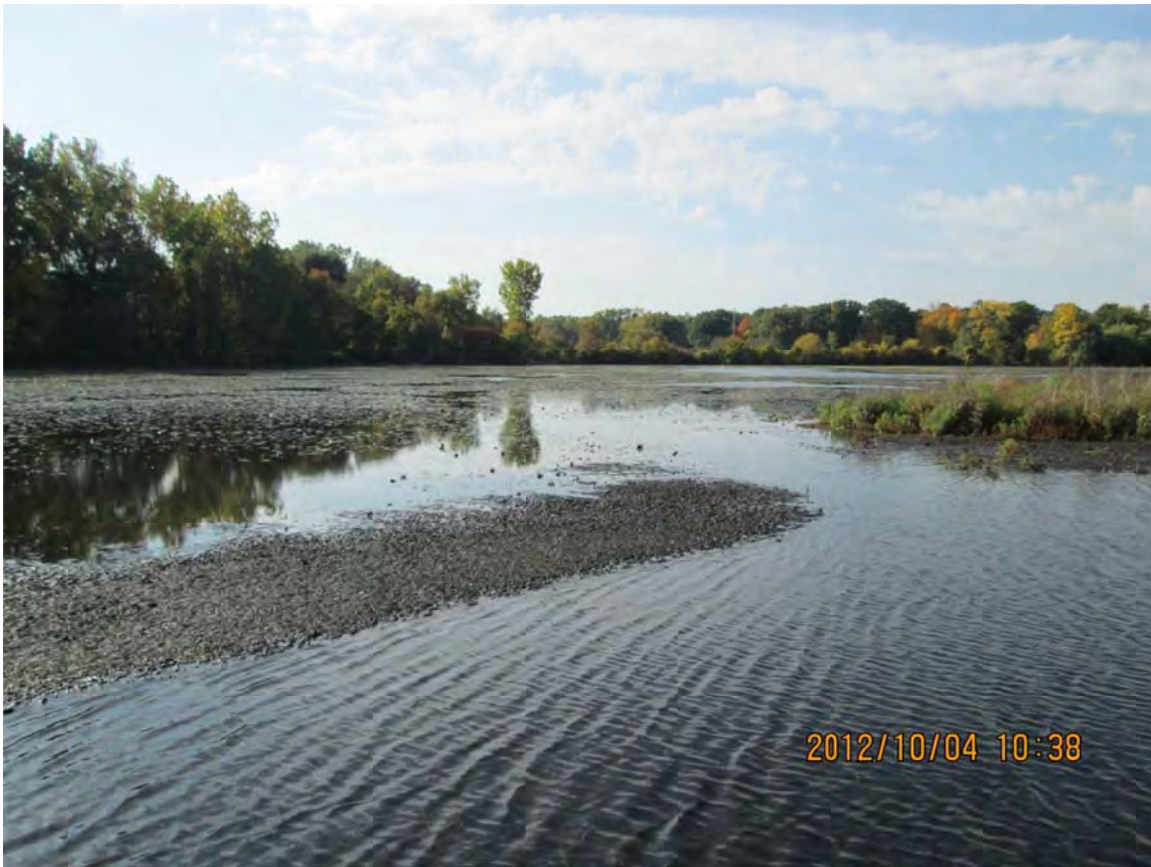
15. MP 15.75 North Mill Pond RDB of river channel, no sheen observed.

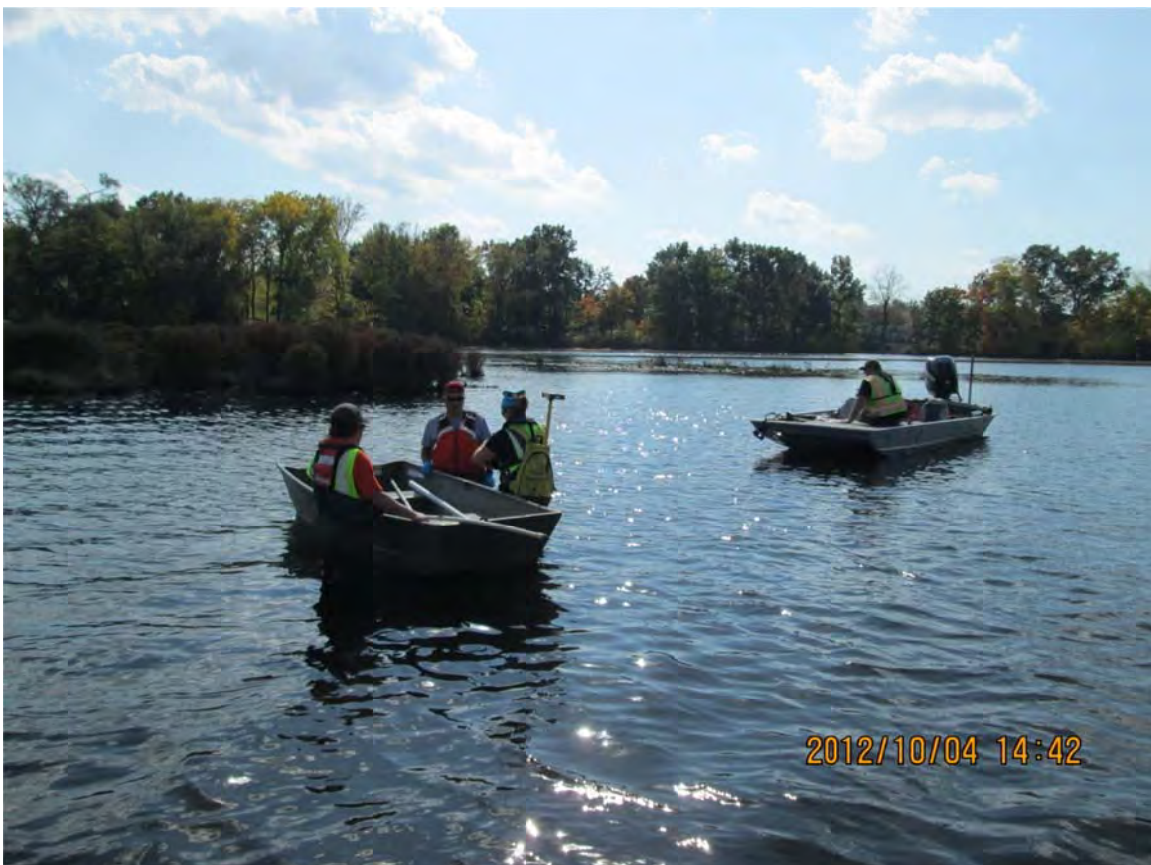
16. Poling crew operating in Delta Z in Morrow Lake Delta.

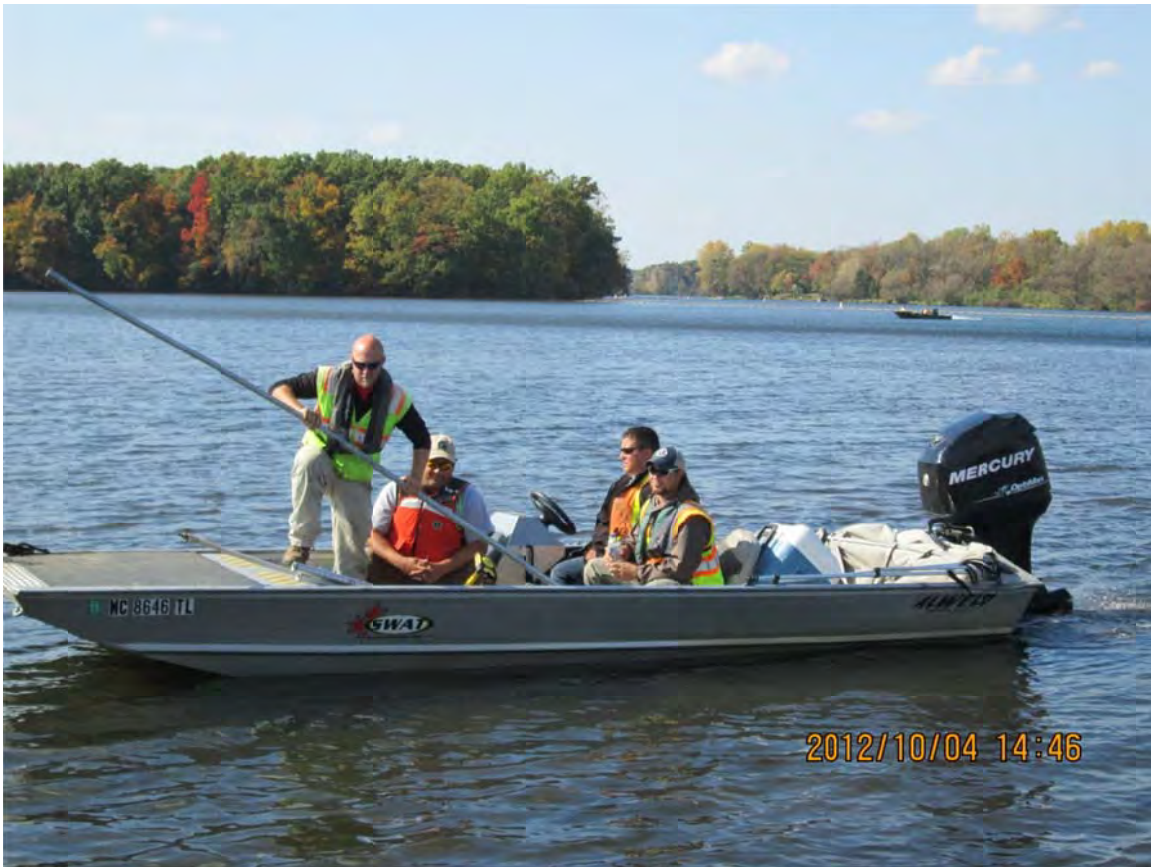
17. Second poling crew observed near Delta Z in Morrow Lake Delta.
